iRobot Roomba 860 Side Brush Replacement

This guide will provide instructions to replace the side brush that directs debris and contaminants towards the debris extractor to be picked up.

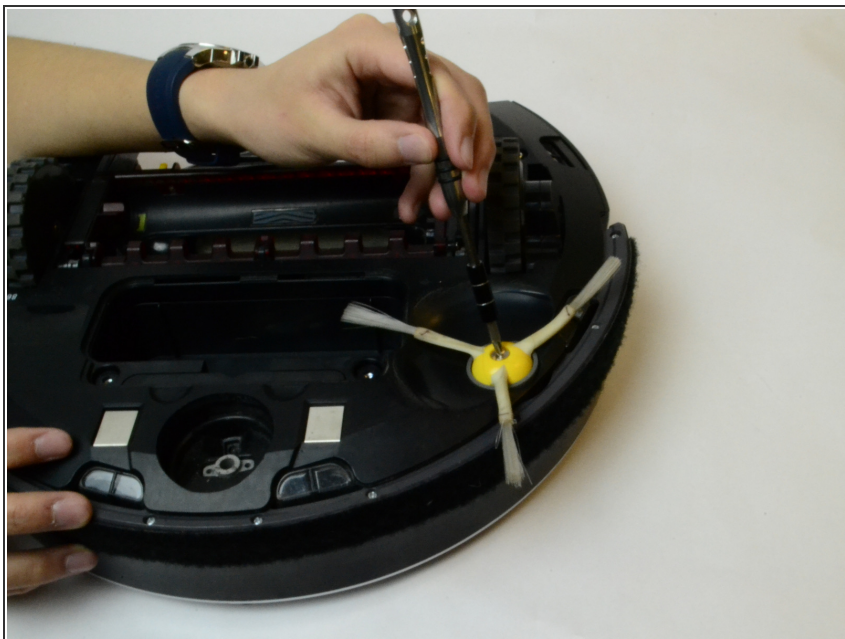
Step 1 — Side Brush

- Start by locating the yellow side brush on the underside of the iRobot Roomba 860 near the front of the device.

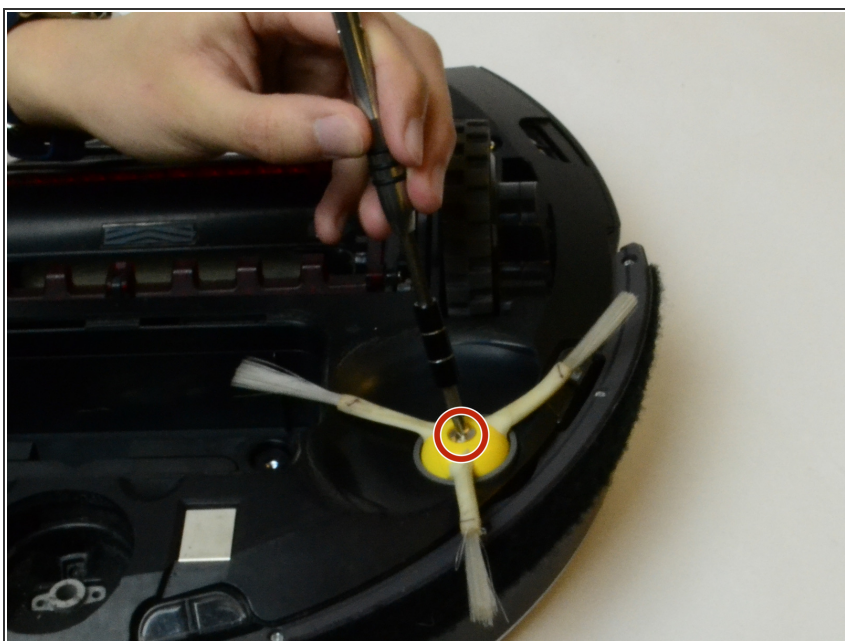
Step 2

- Using a Philips #2 Point Screwdriver, remove the screw located in the center of the brush.

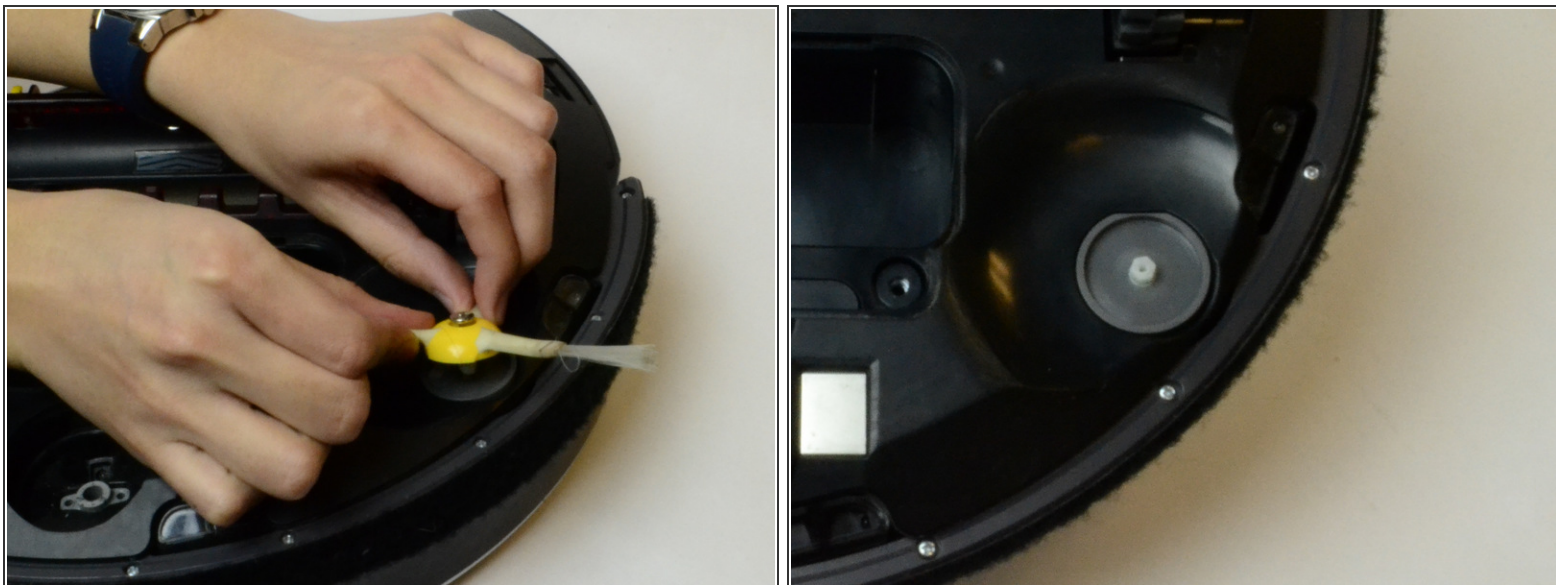
Step 3

- Pull up on the side brush and it should slide off, free of the motor shaft.
- Remove any debris that could be preventing the side brush from spinning and/or replace the side brush.

To reassemble your device, follow these instructions in reverse order.
